PRELIMINARY NONDESTRUCTIVE EVALUATION MANUAL FOR THE SPACE SHUTTLE

**PRELIMINARY NONDESTRUCTIVE EVALUATION MANUAL
FOR THE SPACE SHUTTLE**

APPENDIX TO FINAL REPORT

**LOCKHEED-GEORGIA COMPANY
A DIVISION OF LOCKHEED AIRCRAFT CORPORATION
MARIETTA, GEORGIA 30063**

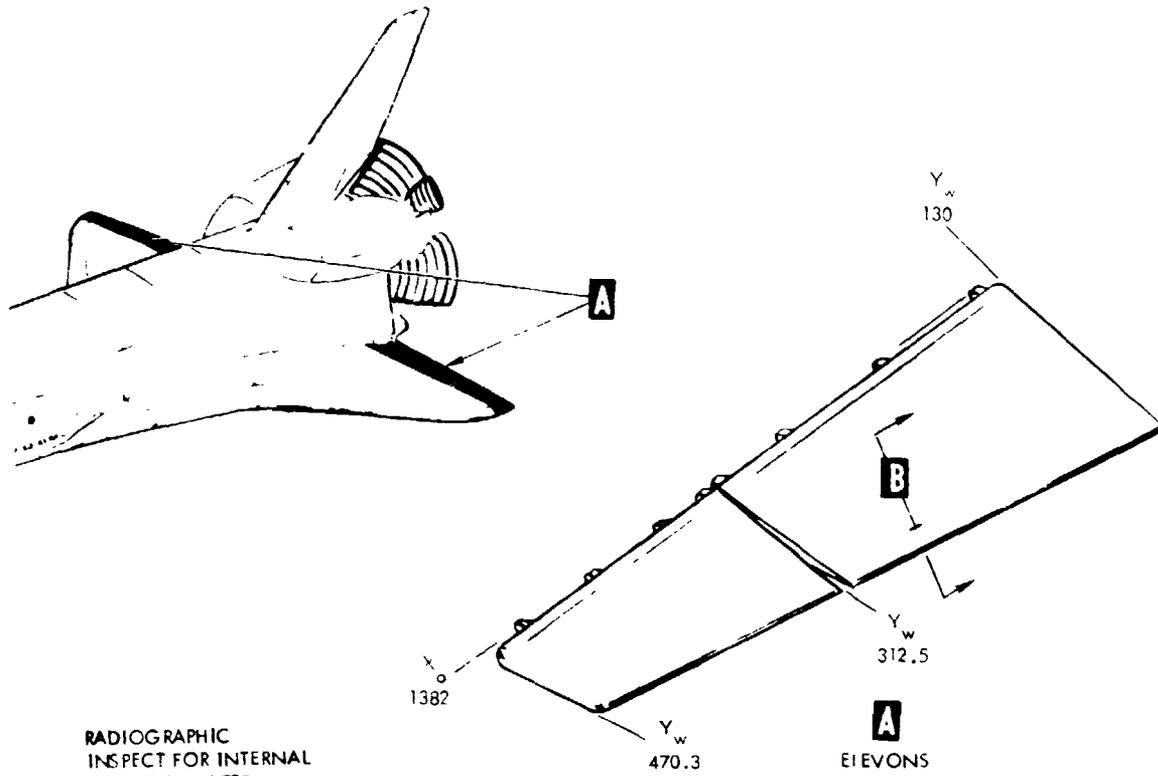
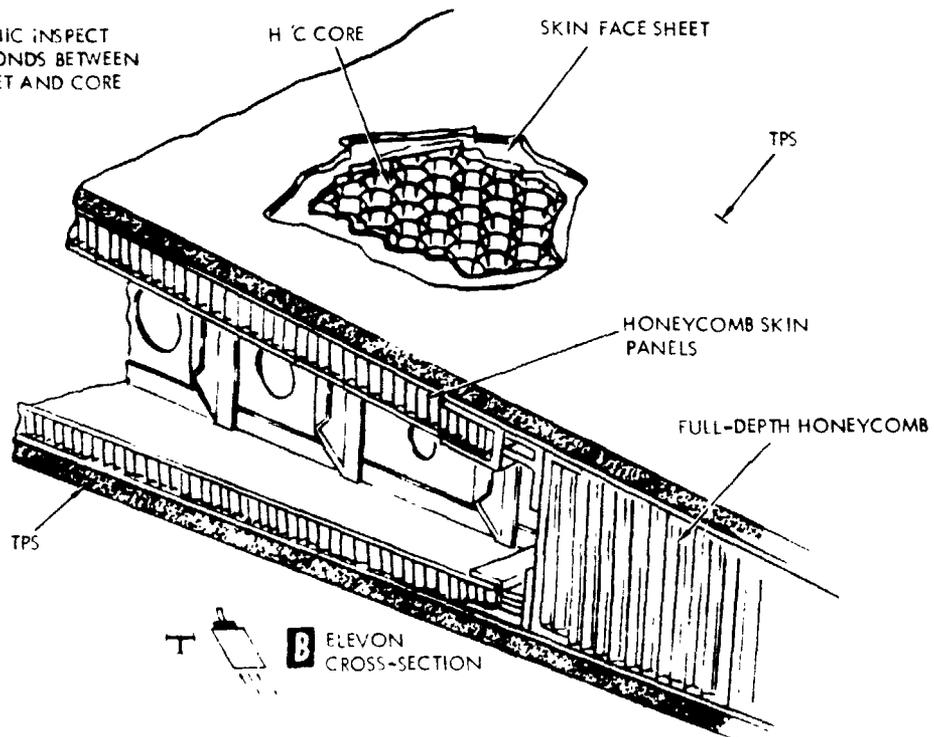
Figure 5-17. Elevation Honeycomb Skin Panels

NDT TECHNIQUES: Primary: X-ray (para. 1.5.6.2) for core general damage and water entrapment. Ultrasonic (para. 1.5.5.6) or thermography (para. 1.5.8.2) for disbond detection and corrosion.

Backup: For disbonds, use mechanical pull test for disbonds greater than TBD diameter.

RADIOGRAPHIC
INSPECT FOR INTERNAL
DAMAGE, WATER
ENTRAPMENT

ULTRASONIC INSPECT
FOR DISBONDS BETWEEN
FACE SHEET AND CORE

PROCEDURE NO. 5-625, Figure 5-17

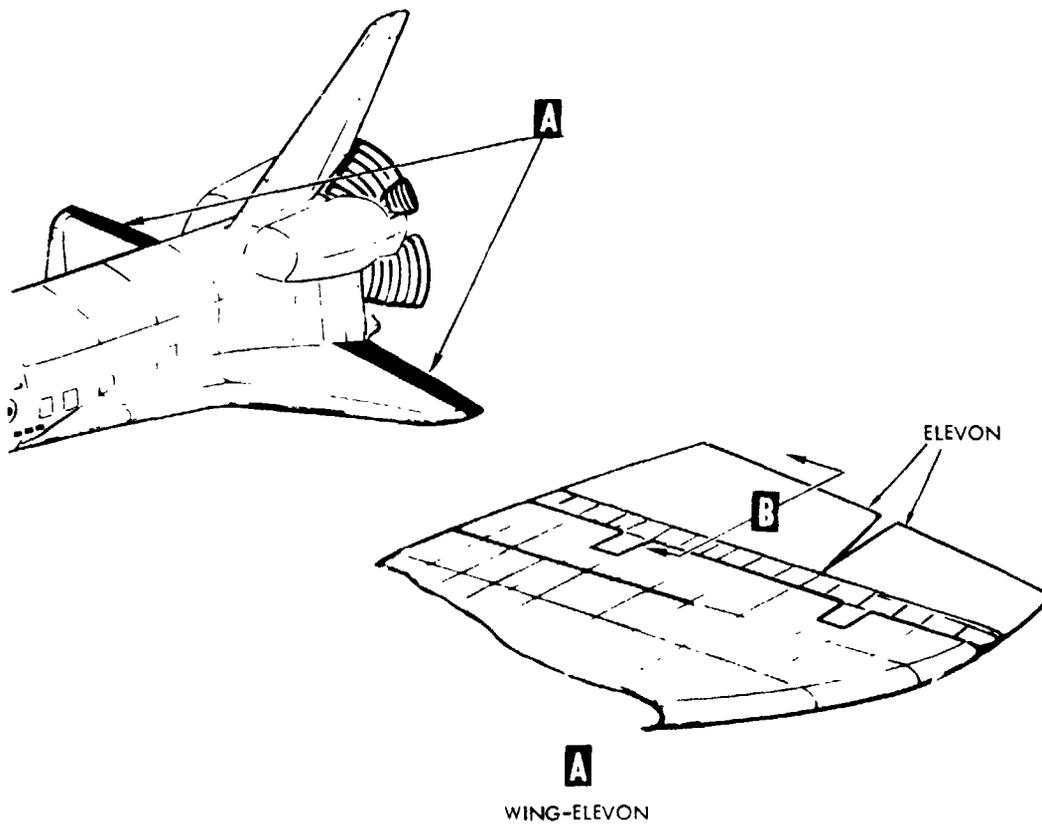
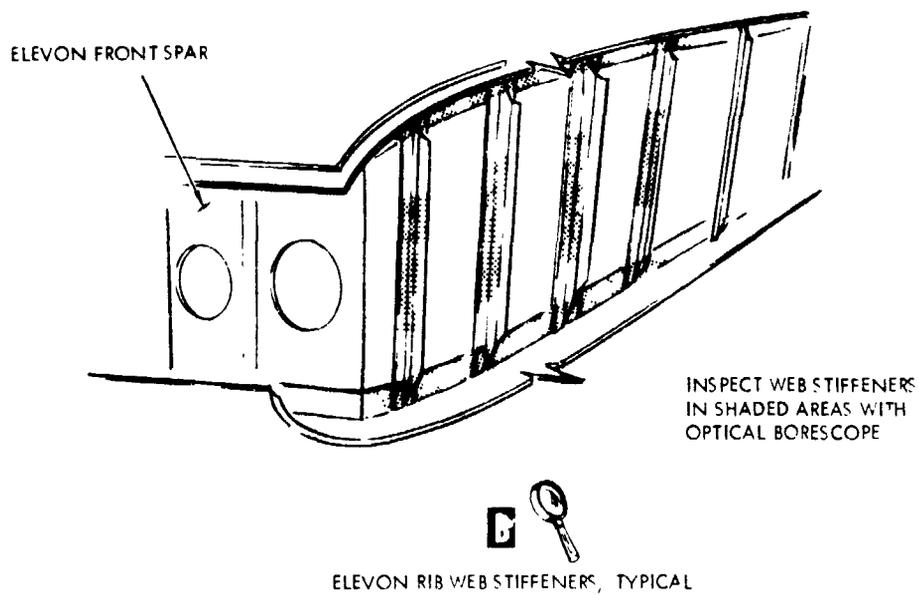
Figure 5-18. Elevon Web Stiffeners

ACCESS: Access to each rib web stiffener is through the lightening holes in the elevon front spar. Thermal seals must be removed and elevon deployed up or down.

NDT TECHNIQUES: Primary: Optical borescope (para. 1.5.1.3)
Backup: Fluorescent penetrant (para. 1.5.2.1 Fig. 1-9)

PROCEDURE NO. 5-626, Figure 5-18

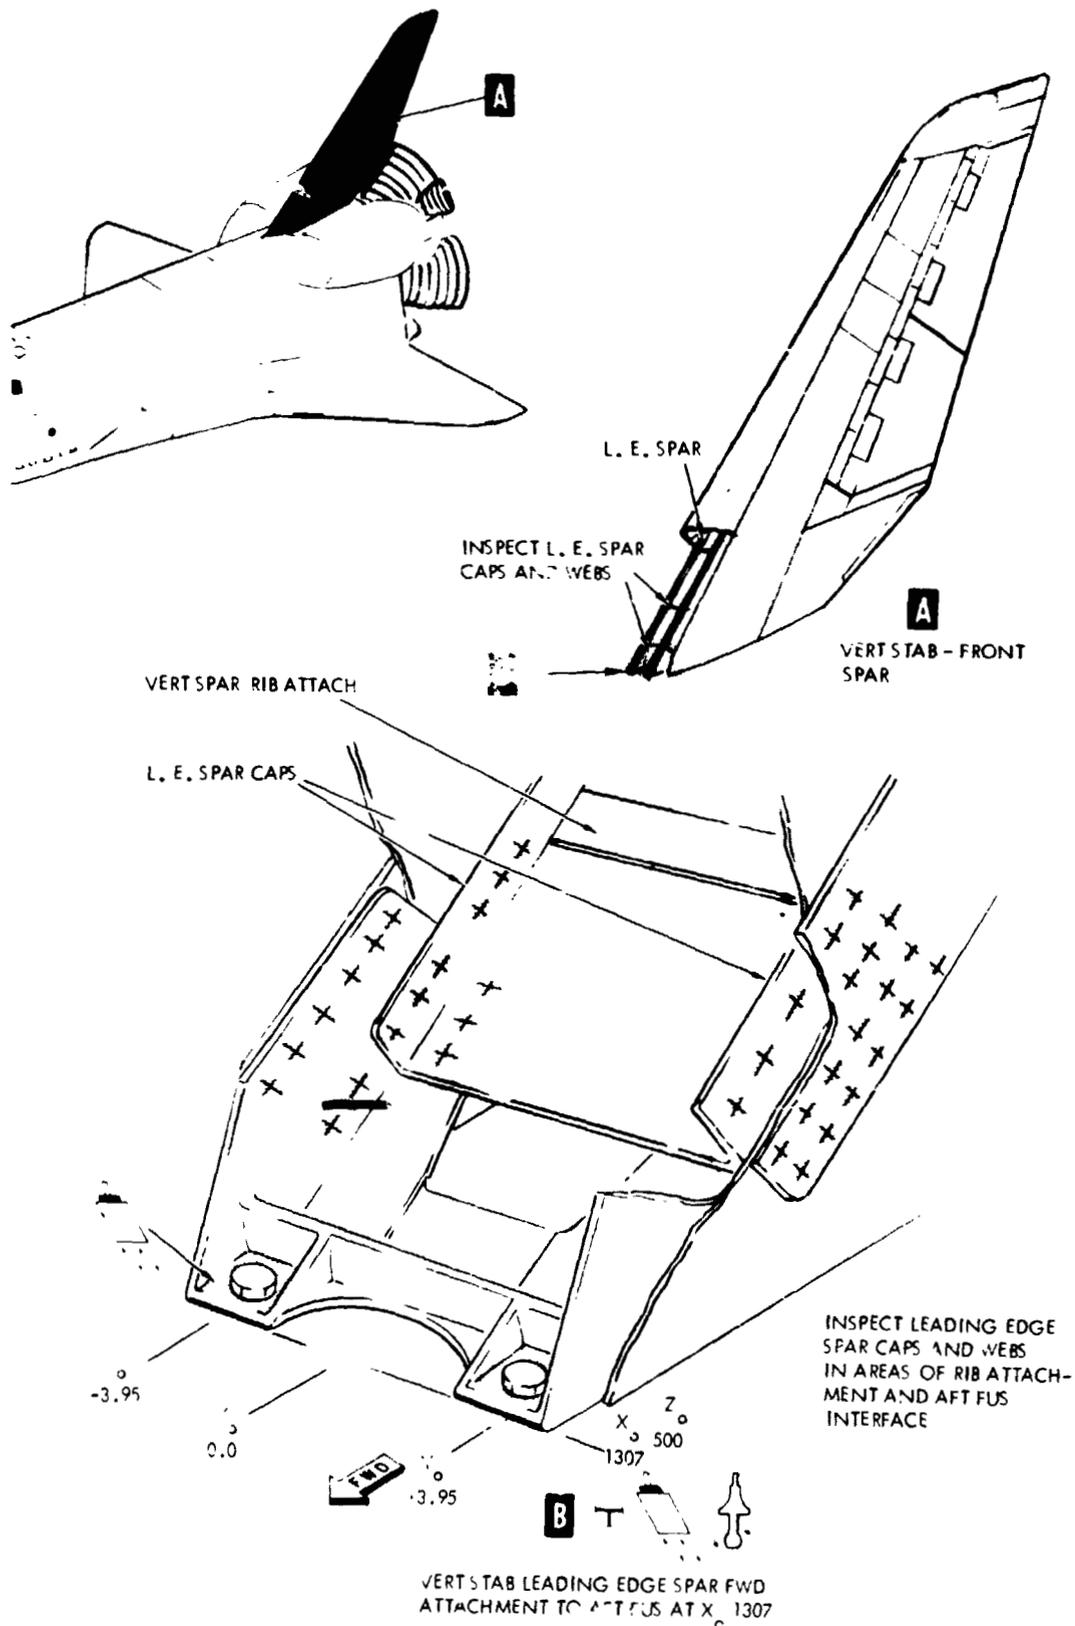
Figure 6-1. Vertical Stabilizer Front Spar Caps

ACCESS: Remove vertical lower leading edge fairings. Some portions of front spar may be sandwiched between fin-fuselage attach fitting and vertical stabilizer skin panels.

NDT TECHNIQUES: Primary: Ultrasonic shear wave (Para. 1.5.5.3C) for V.S.L.E./fus attach; eddy current (Para. 1.5.4.4) (leading edge removed) or radiography (Para. 1.5.6.2) (for sandwiched areas or inspection with leading edge intact).
Backup: Fluorescent penetrant (Para. 1.5.2.1, Fig. 1-9) except for main attach bolt holes for which eddy current bolt hole (Para. 1.5.4.3) should be used.

PROCEDURE NO: 6-701, FIGURE 6-1
MAJOR ASSEMBLY: ORBITER, VERTICAL STABILIZER
ZONE 7
SUBASSEMBLY: VERT STAB FRONT SPAR

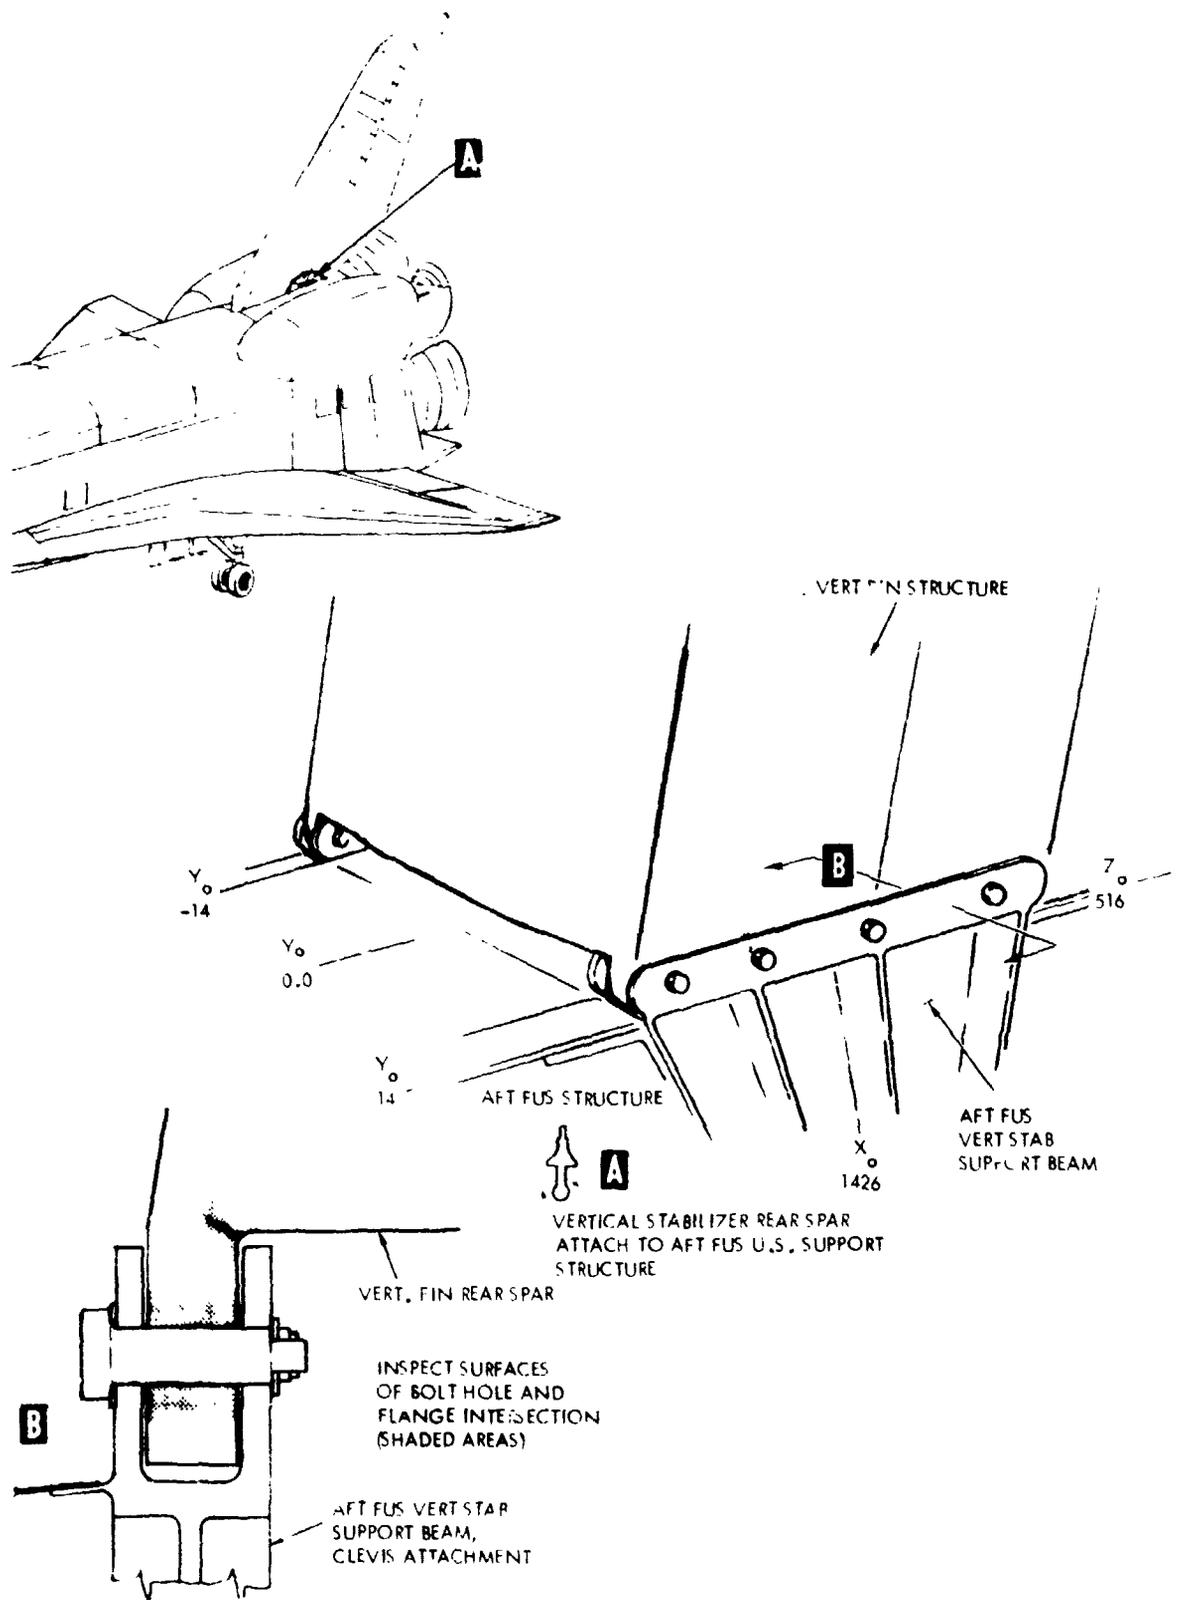
Figure 6-2. Vertical Stabilizer/Fuselage Aft Attachment

ACCESS: (Not clear). For eddy current bolt hole insp, clevis bolt must be removed - only one at a time.

NDT TECHNIQUES: Primary: Eddy current surface probe (Para. 1.5.4.4) for lug fillet inspection; eddy current bolt hole (Para. 1.5.4.3) with clevis bolt removed for bolt hole insp.
Backup: Fluorescent penetrant (Para. 1.5.2.1, Fig. 1-9).

PROCEDURE NO: 6-702, FIGURE 6-2
MAJOR ASSEMBLY: ORBITER, VERTICAL STABILIZER
ZONE 7

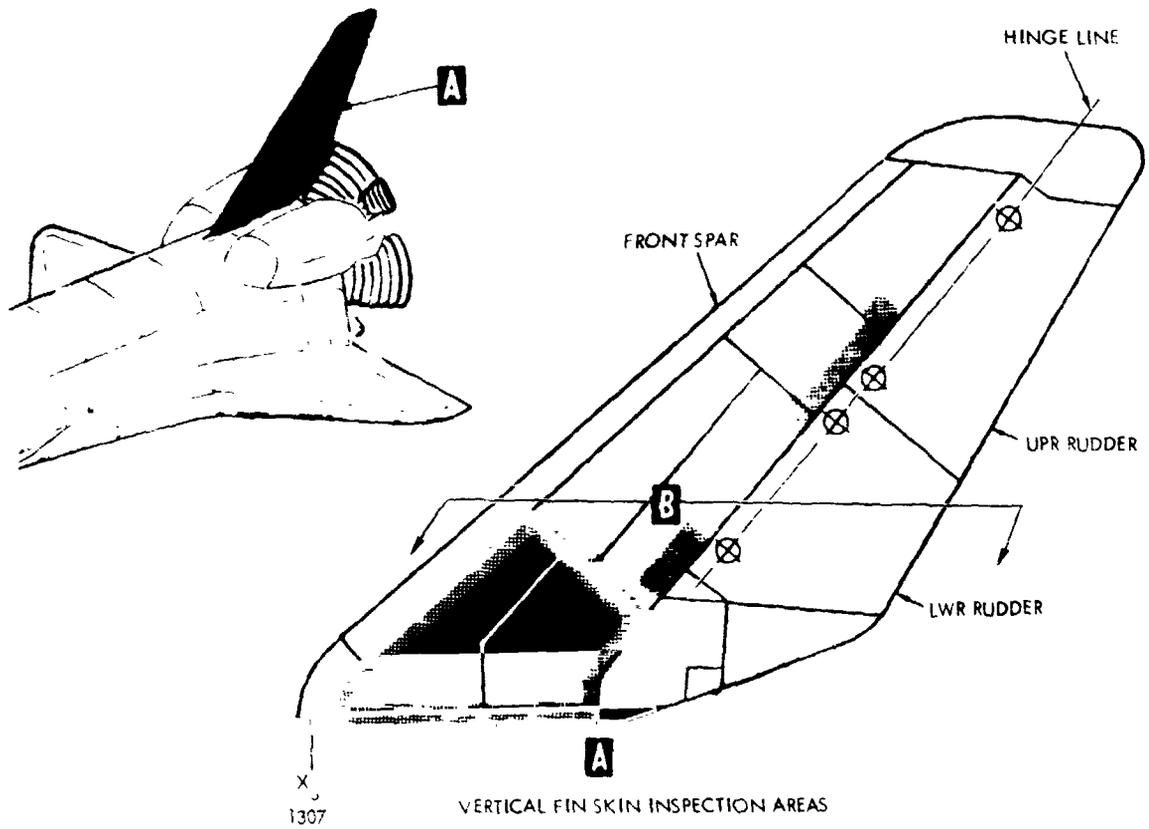
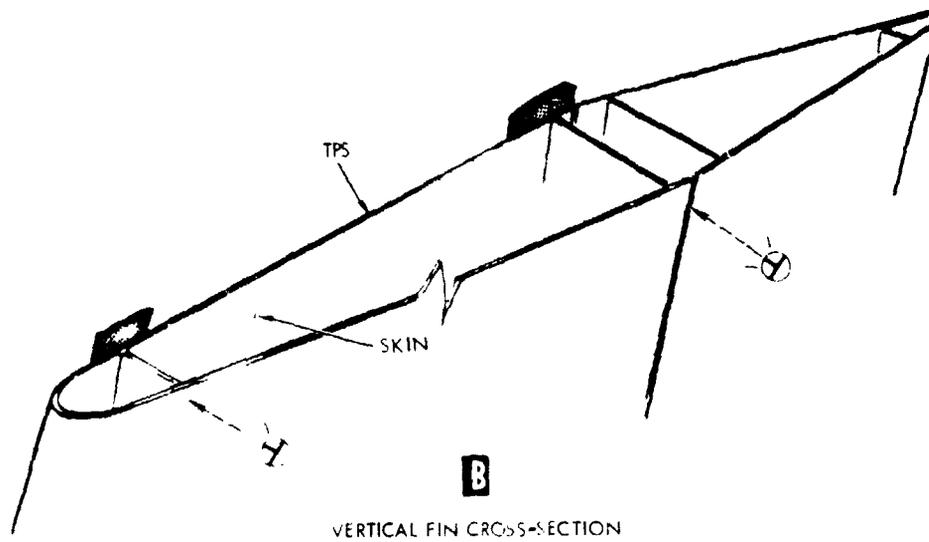
Figure 6-3. Vertical Stabilizer Skins

ACCESS: TPS panels prevent direct access from the outside. Limited access to vertical fin interior. Local TPS panels must be removed to apply backup inspection.

NDT TECHNIQUES: Primary: X-ray (Para. 1.5.6.2) for gross cracks in skin panels (if TPS panels are removed, visual, eddy current, and /or penetrant NDE can be applied).
Backup: Fluorescent penetrant (Para. 1.5.2.1, Fig. 1-9) or eddy current (Para. 1.5.4.4).

PROCEDURE NO: 6-703, FIGURE 6-3
MAJOR ASSEMBLY: ORBITER, VERTICAL STABILIZER, TYPE INSPECTION:
ZONE 7 (X) POSTFLIGHT
SUBASSEMBLY: VERTICAL FIN
DRAWING(S): 170G400000

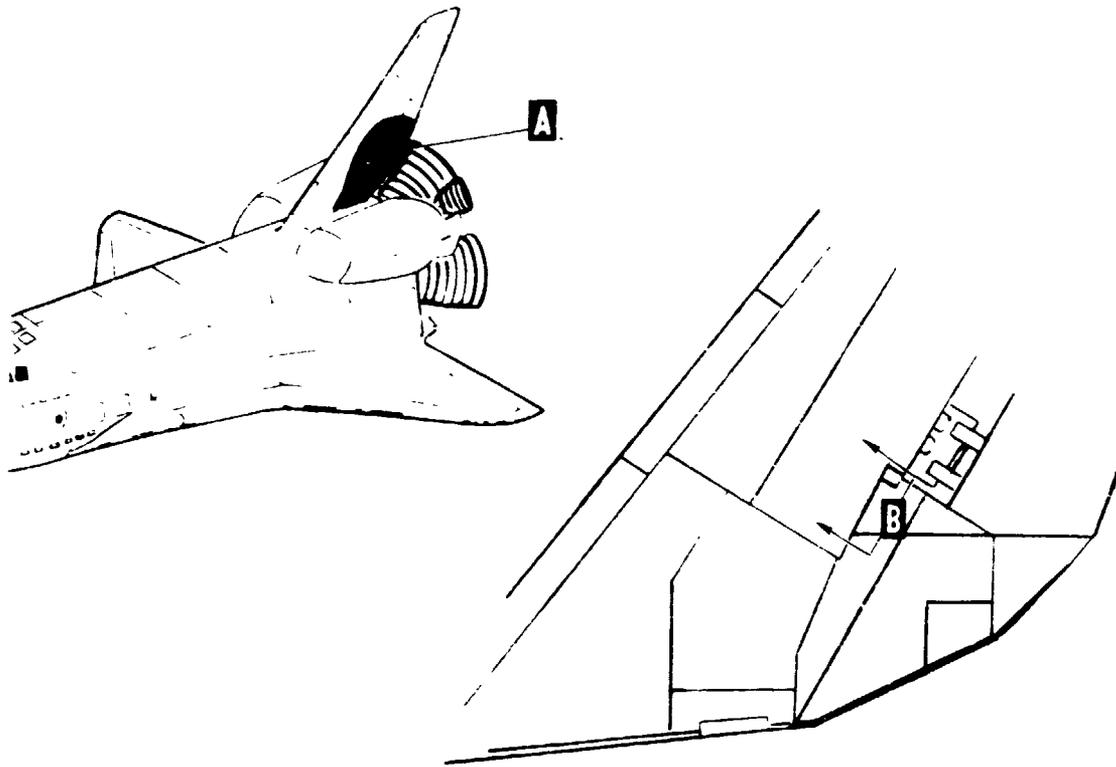
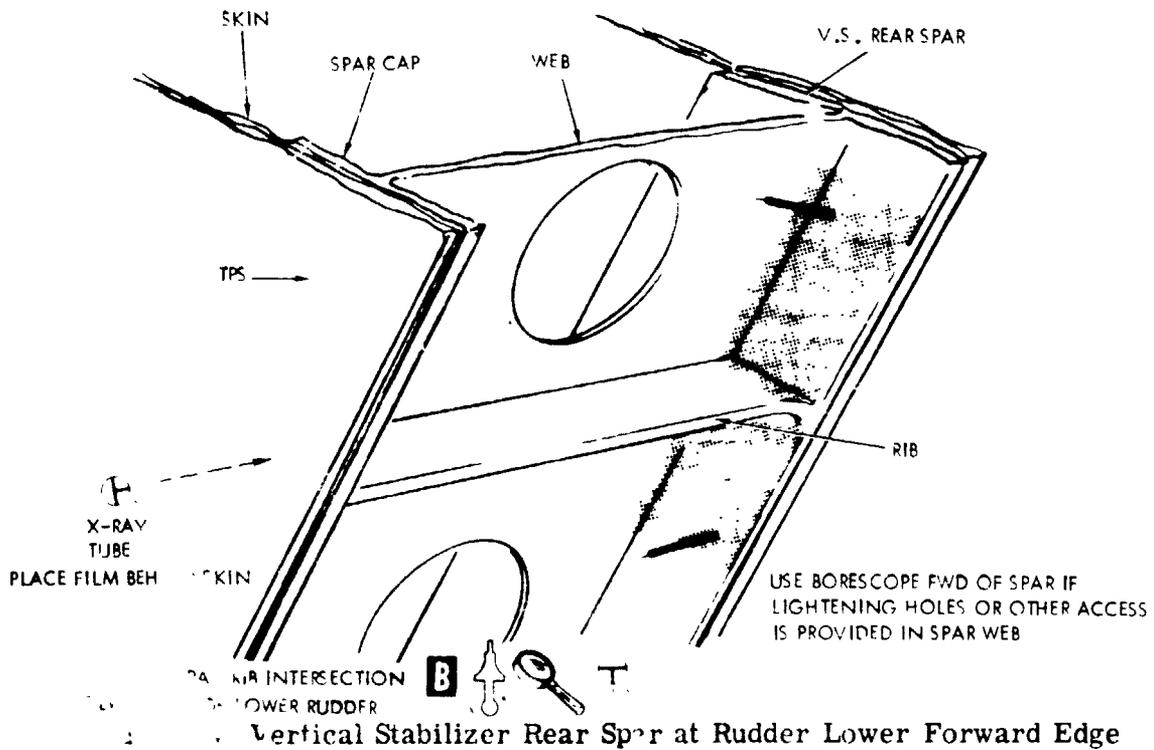
Vertical Stabilizer Rear Spar at Rudder Lower Forward Edge

ACCESS: Remove the local lower rudder thermal seal as necessary and spar access panels. Some access is also obtained through the drag chute compartment with the chute removed.

NDT TECHNIQUES: Primary: Eddy current surface probe (Para. 1.5.4.4) and optical borescope (Para. 1.5.1.3). X-ray radiography (Para. 1.5.6.2) may be used for inaccessible sandwich structure.
Backup: Fluorescent penetrant (Para. 1.5.2.1, Fig. i-9).

VERTICAL STABILIZER, LOWER AREA

PROCEDURE NO.: 6-704, FIGURE 6-4
MAJOR ASSEMBLY: ORBITER, VERTICAL STABILIZER,
ZONE 7

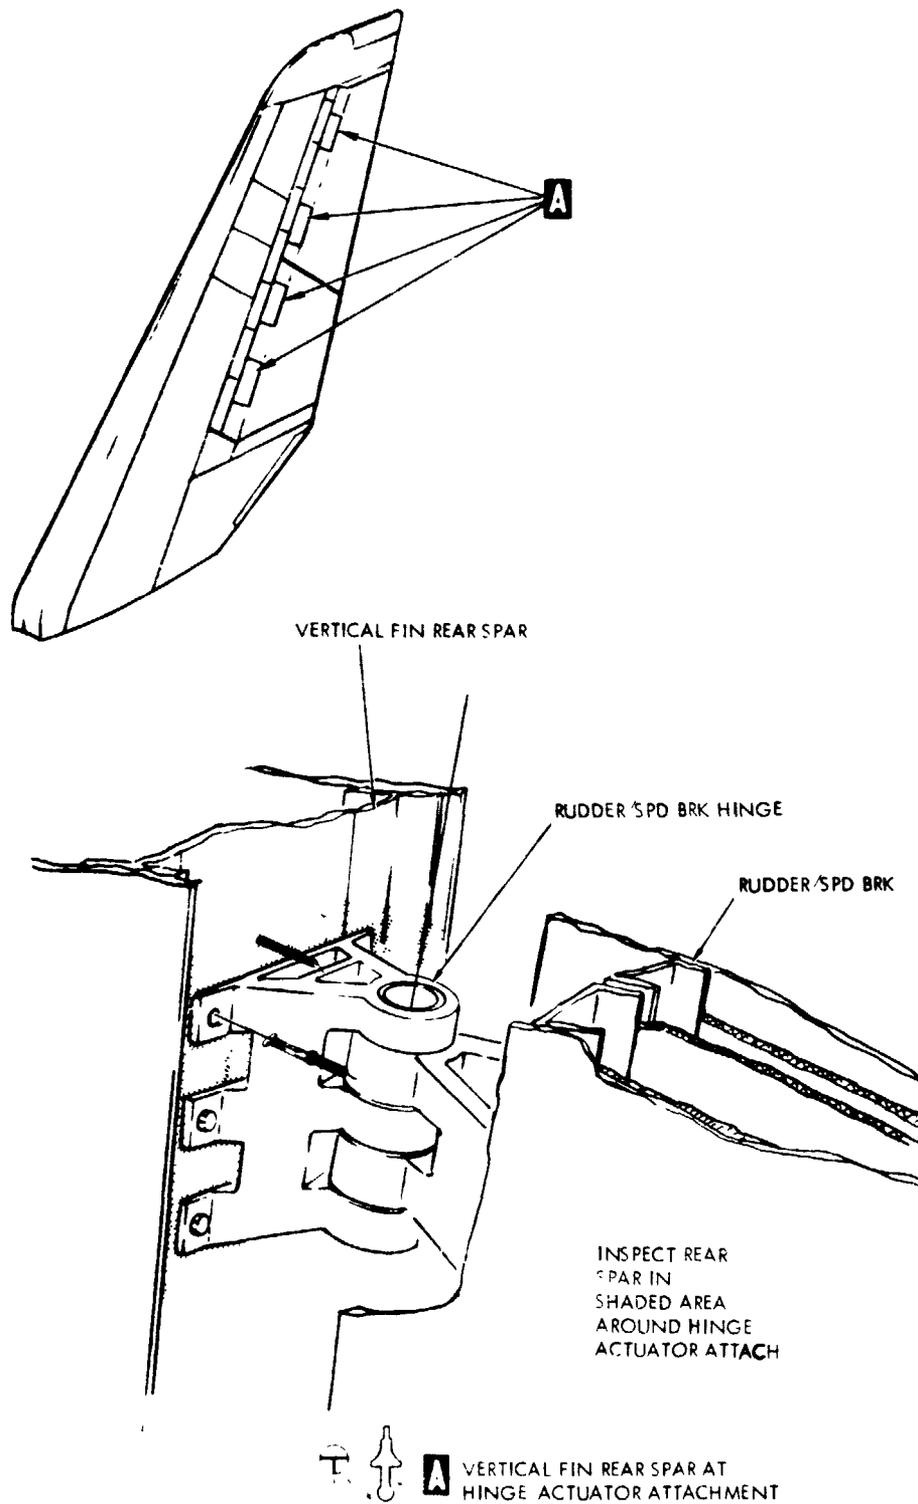
Figure 6-5. Rudder/Speed Brake Actuator and Hinge/Vertical Stabilizer Rear Spar Attach

ACCESS: Access to the attach fittings and adjacent vertical fin rear spar structure is attained by removing the Rudder/Speed Brake Actuator panels on the vertical tail. Additional inspection of actuator attachments (adjacent l.e. structure) can be made when the rudder thermal seals are removed. Remove hinge/rear spar bolts for hole inspection.

NDT TECHNIQUES: Primary: Eddy current surface probe (Para. 1.5.4.4) and bolt-hole probe (Para. 1.5.4.3).
Backup: Fluorescent penetrant (Para. 1.5.2.1, Fig. 1-9).

PROCEDURE NO: 6-705, FIGURE 6-5
MAJOR ASSEMBLY: ORBITER, VERTICAL STABILIZER,
ZONE 7

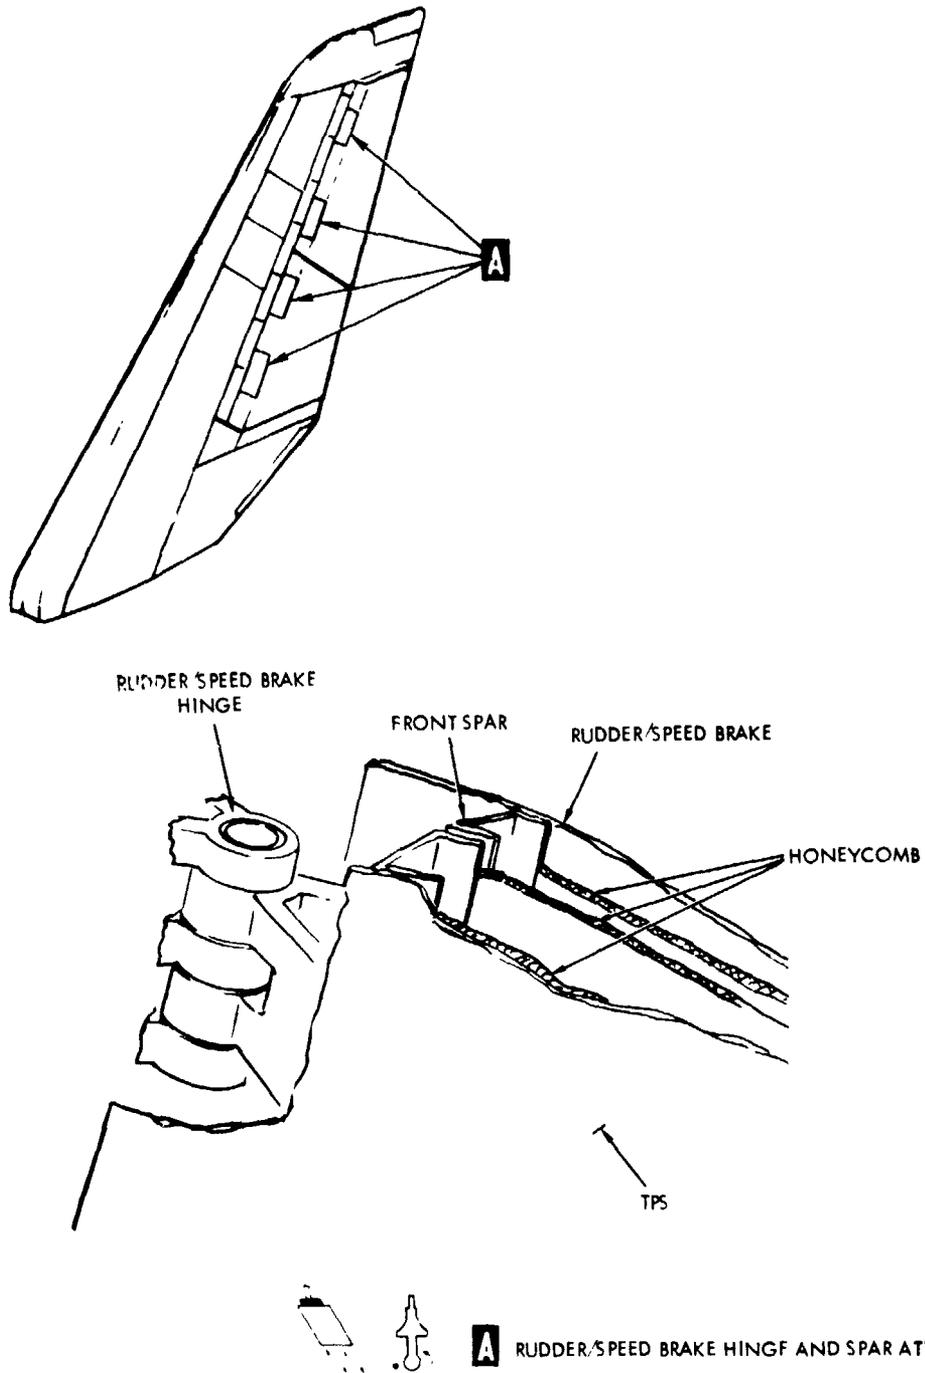
Figure 6-6. Rudder Speed Brake Actuator/Hinge (Sheet 1 of 2)

Backup: Eddy current bolt hole (Para. 1.5.4.2) and
fluorescent penetrant (Para. 1.5.2.1, Fig. 1.9).

PROCEDURE NO: 6-706, FIGURE 6-6
MAJOR ASSEMBLY: ORBITER, VERTICAL STABILIZER,
ZONE 7
SUBASSEMBLY: RUDDER/SPD BRAKE HINGES
DRAWING(S): VL72-001034, VL72-000104 'A'
FAIRCHILD 170G400000, 170G411000

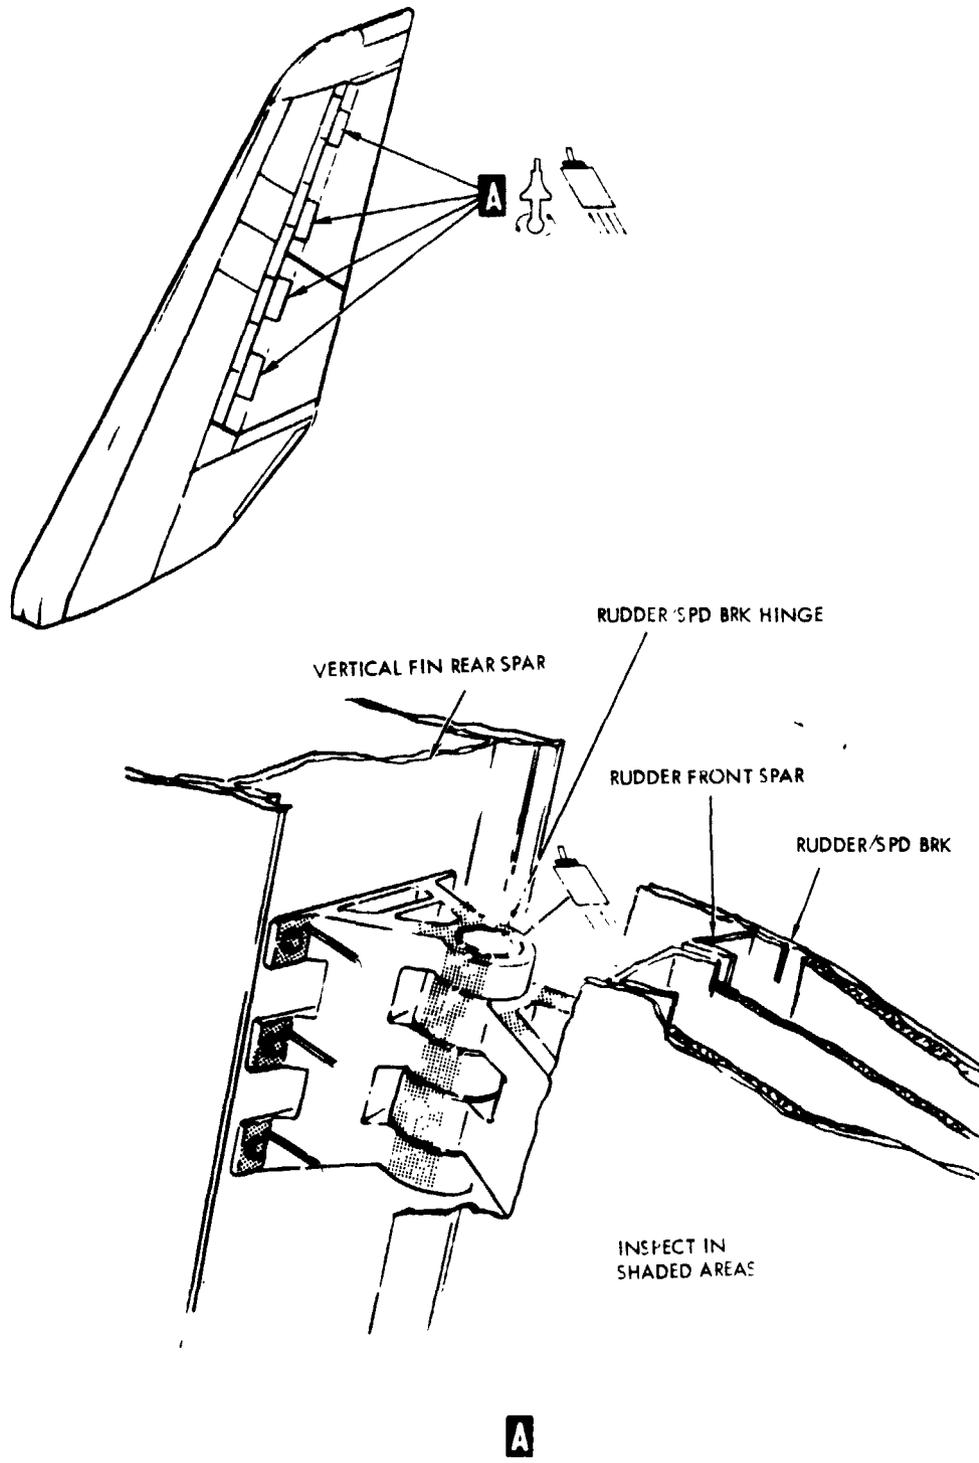
Figure 6-6. Rudder/Speed Brake Actuator/Hinge (Sheet 2 of 2)

RUDDER 'SPEED BRAKE HINGE FITTINGS, TYPICAL

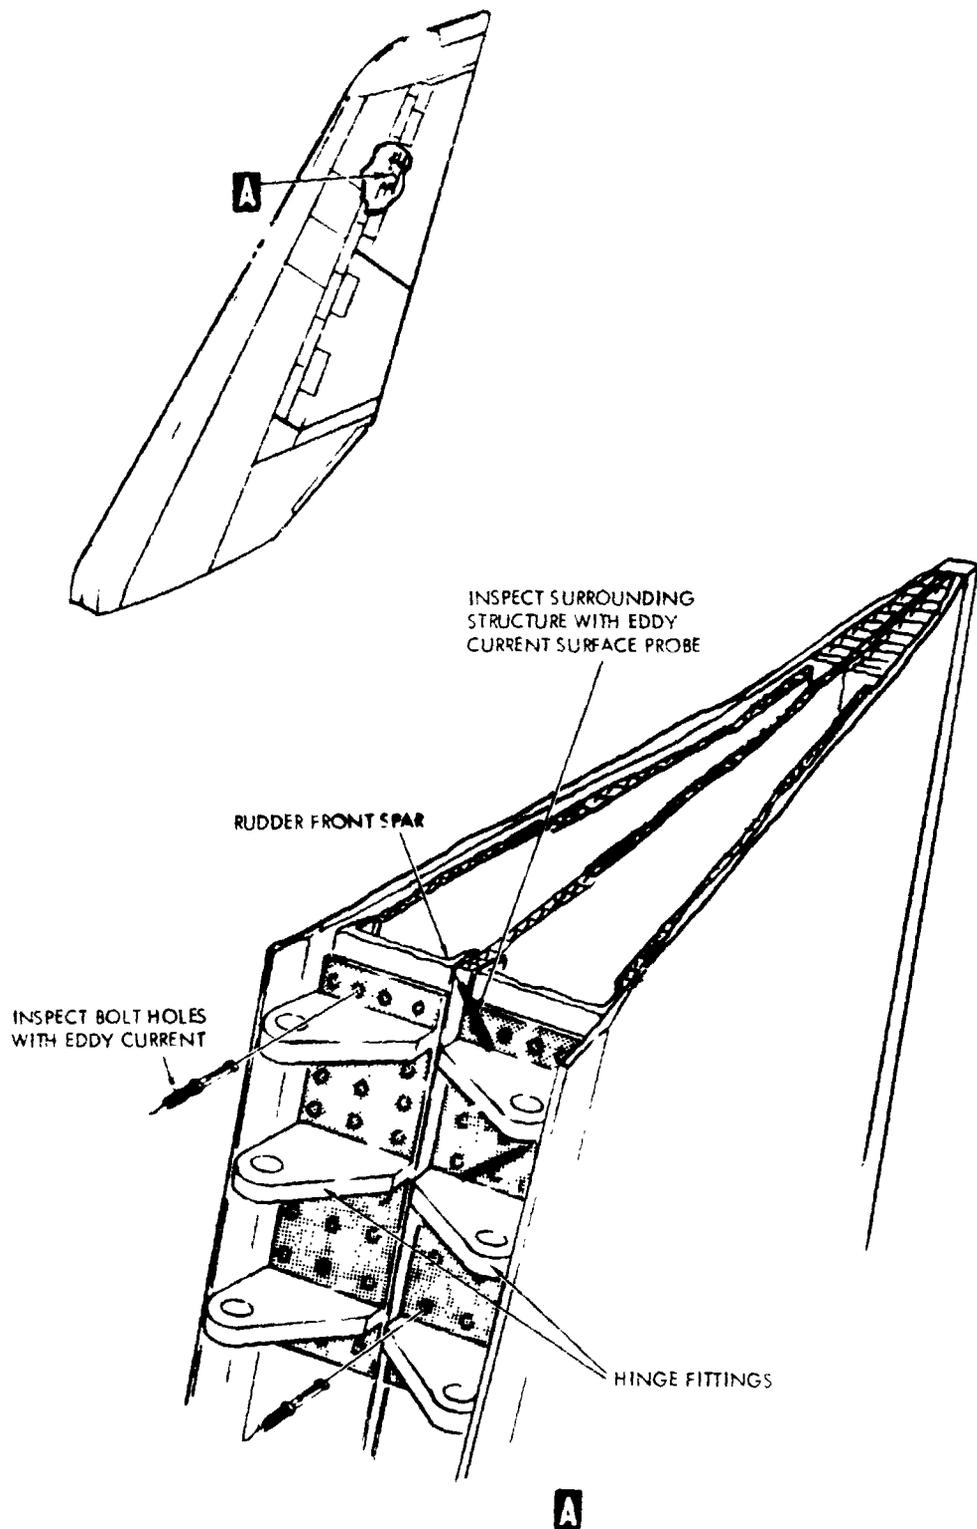
Figure 6-7. Rudder Front Spar

COMPONENT/AREA DESCRIPTION: RUDDER FRONT SPAR. The rudder front spar, made of 2024-T3511 aluminum alloy forging and having a zinc chromate primer and Supercorapon 515-700 paint surface finish, is subject to fatigue damage in the attachment areas to rudder hinges and actuators and closeout ribs. The actuators deploy the rudders and speed brakes into the airstream to affect yaw or speed reduction, respectively. The areas may be highly stressed during atmospheric flight maneuvers, particularly in the approach and landing sequence in which high shear and compressive loads are applied to the spar. The safe-life designed spar comprises the forward closure of the rudder box, upper and lower halves.

DEFECTS: Through-cracks between fastener holes where attachments are made to hinge and actuator fittings and honeycomb closeout panels.

ACCESS: (Not well defined). Rudder hinge opening thermal seals must be withdrawn. Access to aft side of spar may be limited. Access is through lightening/access holes in fwd spar.

NDT TECHNIQUES: Primary: Optical borescope (Para. 1.5.1.3) or radiography (Para. 1.5.6.2) (if access permits placement of film behind spar).
Backup: Fluorescent penetrant (Para. 1.5.2.1, Fig. 1-9).

PROCEDURE NO: 6-707, FIGURE 6-7
MAJOR ASSEMBLY: ORBITER, VERTICAL STABILIZER,
ZONE 7
SUBASSEMBLY: RUDDER/SPEED BRAKE
DRAWING(S): 170G411000 (FAIRCHILD)
(Ref. Fig. 1.8.3) 73MA5769

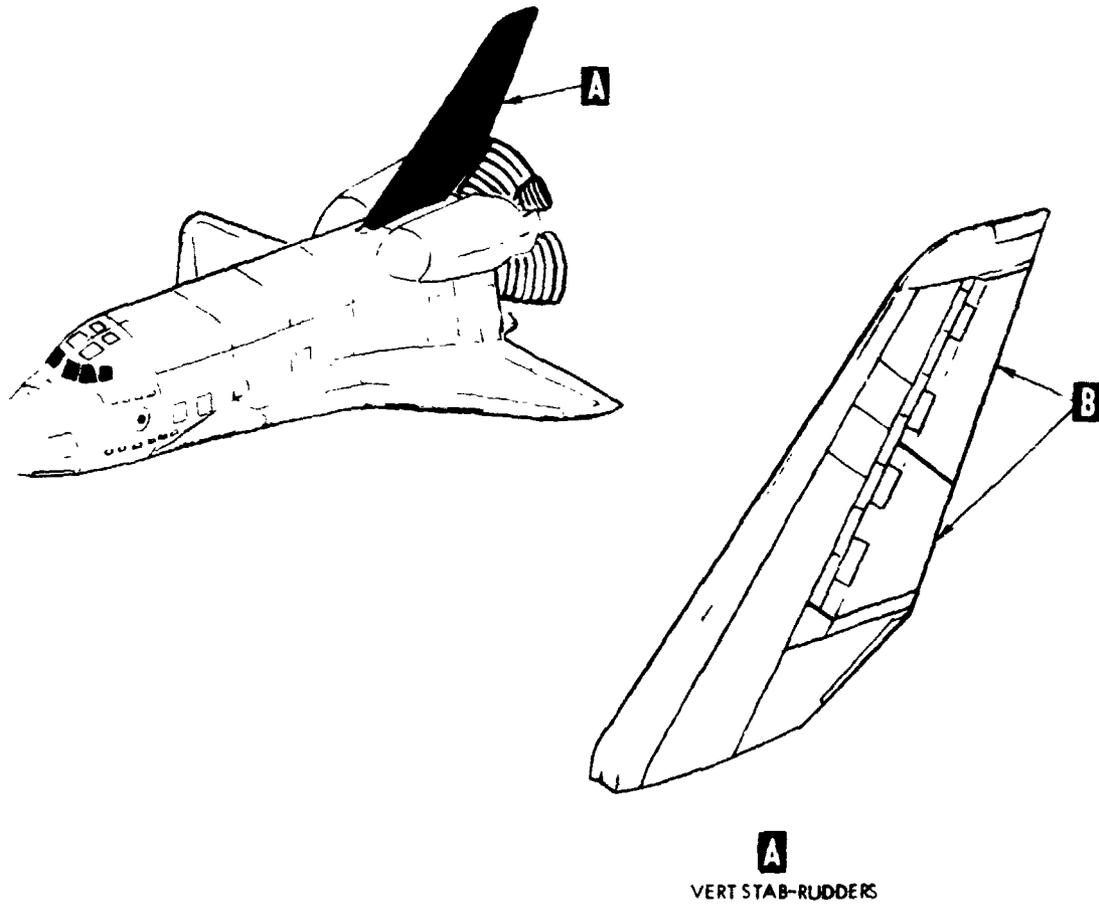
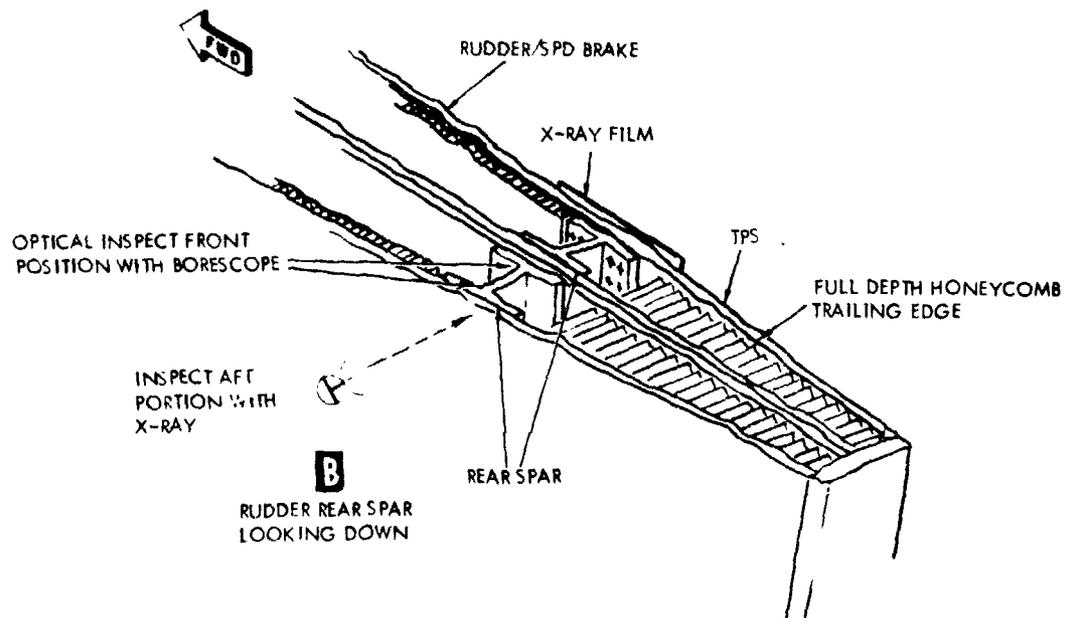
Figure 6-8. Rudder Rear Spar

COMPONENT/AREA DESCRIPTION: RUDDER/SPEED BRAKE REAR SPAR. The rudder rear spar is made of 2024-T86 aluminum alloy formed sheet and has a zinc chromate primer and one (1) coat of Supercorapon 515-700 finish. The rear spar closes out the rudder box assembly and supports the full-depth honeycomb rudder trailing edge. Aerodynamic loads are imposed on the rear spar when the rudder or speed brakes are deployed in atmospheric flight, potentially causing damage in some locations.

DEFECTS: Cracks at rudder rear spar cap attachments to skin and rudder full-depth honeycomb trailing edge, particularly in vicinity of upper and lower extremities of rudder.

ACCESS: Deploy rudder right or left and remove rudder thermal seals as necessary. Access for rear spar inspection is through rudder fwd spar access holes.

NDT TECHNIQUES: Primary: Optical Borescope (Para. 1.5.1.3) and X-ray Radiography (Para. 1.5.6.2).
Backup: TBD.

PROCEDURE NO: 6-708, FIGURE 6-8
MAJOR ASSEMBLY: ORBITER, VERTICAL STABILIZER,
ZONE 7
SUBASSEMBLY: RUDDER/SPEED BRAKE
DRAWING(S): 170G411000

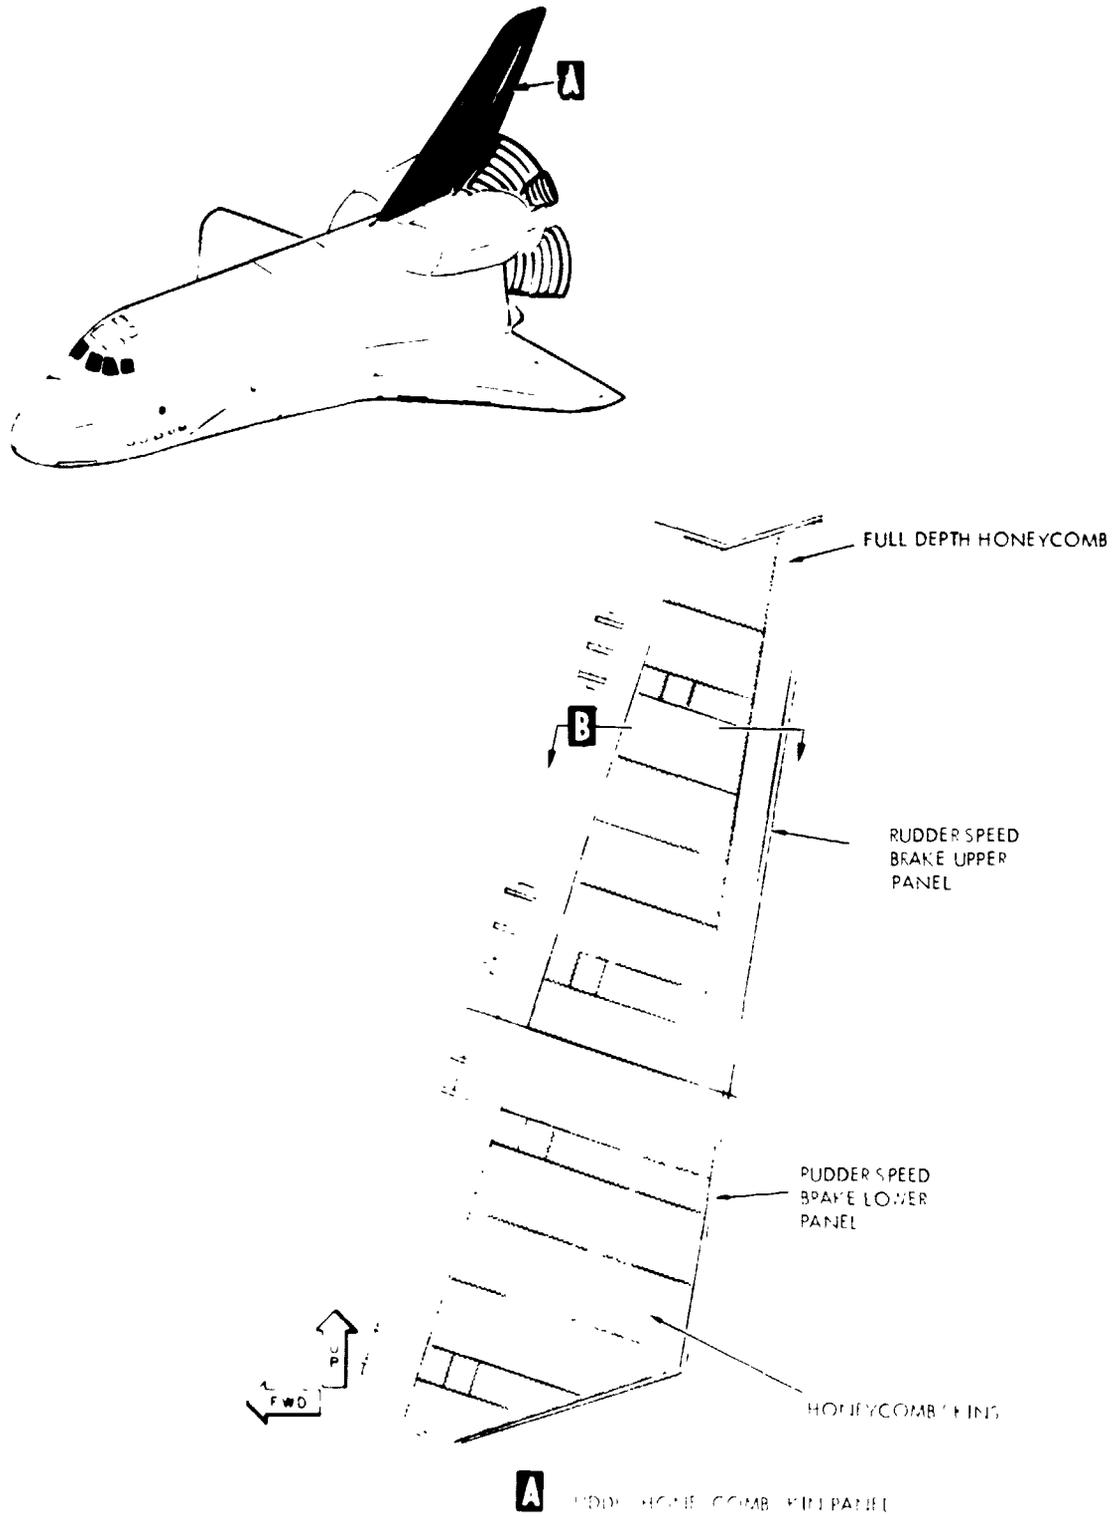
Figure 6-9. Rudder/Speed Brake Honeycomb Skin Panels (Sheet 1 of 2)

PANELS. The rudder/speed brake is a split, two-section assembly hinged to the vert. stab. rear spar along the 60% chord line. These yaw/speed control surfaces consist of conventional stiffened skins with ribs and spars for primary load carrying members. The skin panels are made of bonded 2024-T86 aluminum alloy facesheets and aluminum honeycomb core. Repeated exposure to vibroacoustic, aerodynamic and thermomechanical loads may cause core-to-facesheet separations in the honeycomb panels. In addition, residual reactive gases and water vapor inside the honeycomb core may cause corrosion damage to the aluminum core walls.

DEFECTS: Core-to-facesheet disbonds or separations; core damage due to corrosion vapors and/or water (ice) damage.

NDT TECHNIQUES: Primary: X-ray (Para. 1.5.6.2) for core damage and water entrapment; sonic (Para. 1.5.5.6) or thermographic (Para. 1.5.8.2) for core-to-facesheet separations.

Backup: Mechanical pull test for disbonds greater than TBD inches diameter.

PROCEDURE NO: 6-709, FIGURE 6-9
